TJ PROPERTY INSPECTIONS

Inspection Report

Property: Rua [REDACTED], Porto

Date of inspection: 05.04.2019

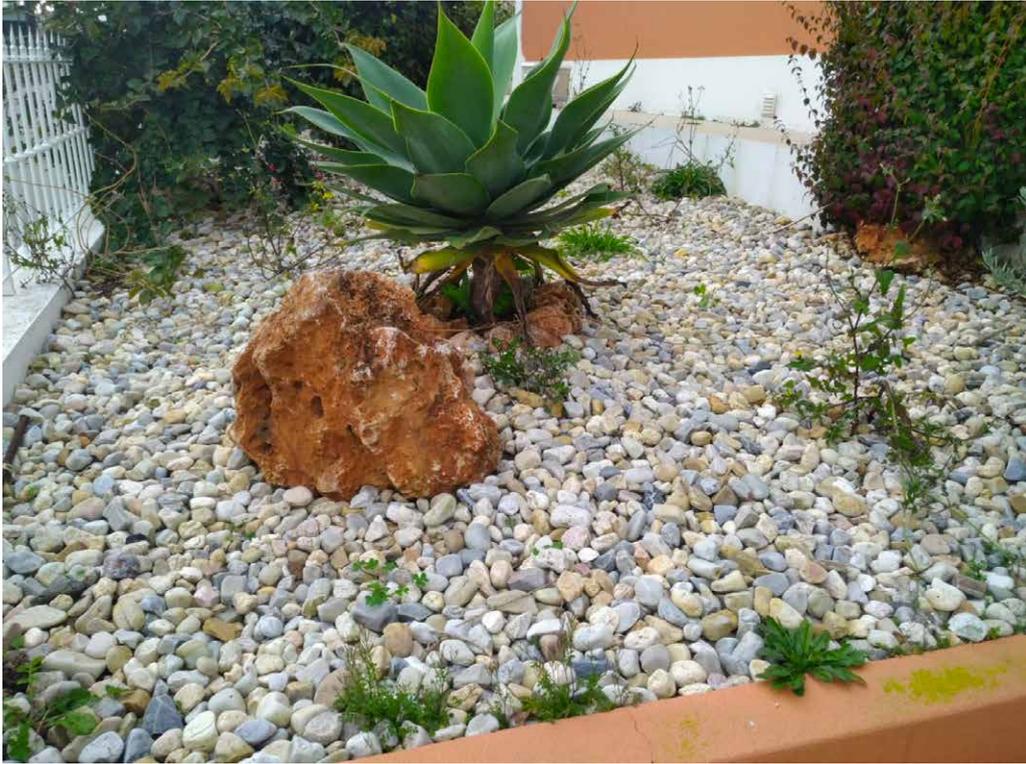
Image 1

The stone garden in the front of the house (image 1) will be absorbing large amounts of water from the roof during rains, this is good to be aware of, and can potentially cause problems in the future. Only one water outlet was noted in the front retaining fence. Several more should be installed.

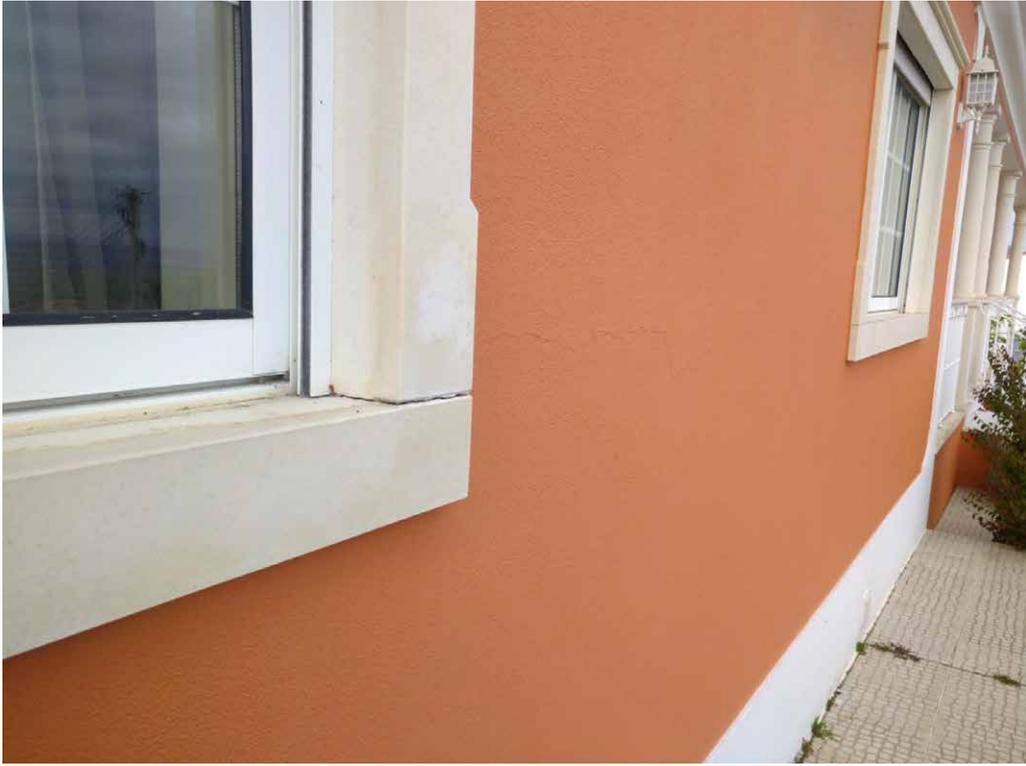
Image 2

One crack was noted, including movement in window outer casing (image 2) the crack had been repaired poorly (unfortunately the crack does not show up in the photo). Of course there is always some movement in a structure. The crack runs horizontal. I see no additional problems occurring from this movement.

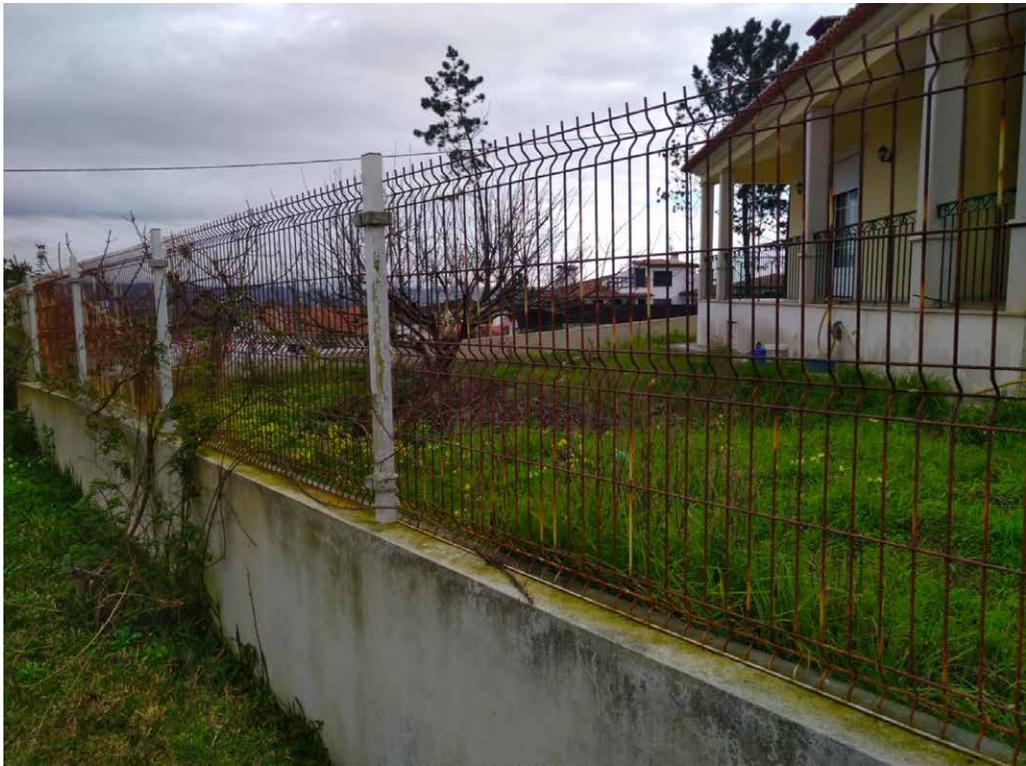
Image 3

The fence between the residence, and the left side neighbour (image 3), is structurally sound, but is showing extreme rust due to low grade materials having been used. Various other forms of fencing have been used to enclose the property, these are presenting well.

It is not cost effective to paint. A new fence of a similar design will cost approx. 700 euros for supply and install, this should require only a single day for completion.

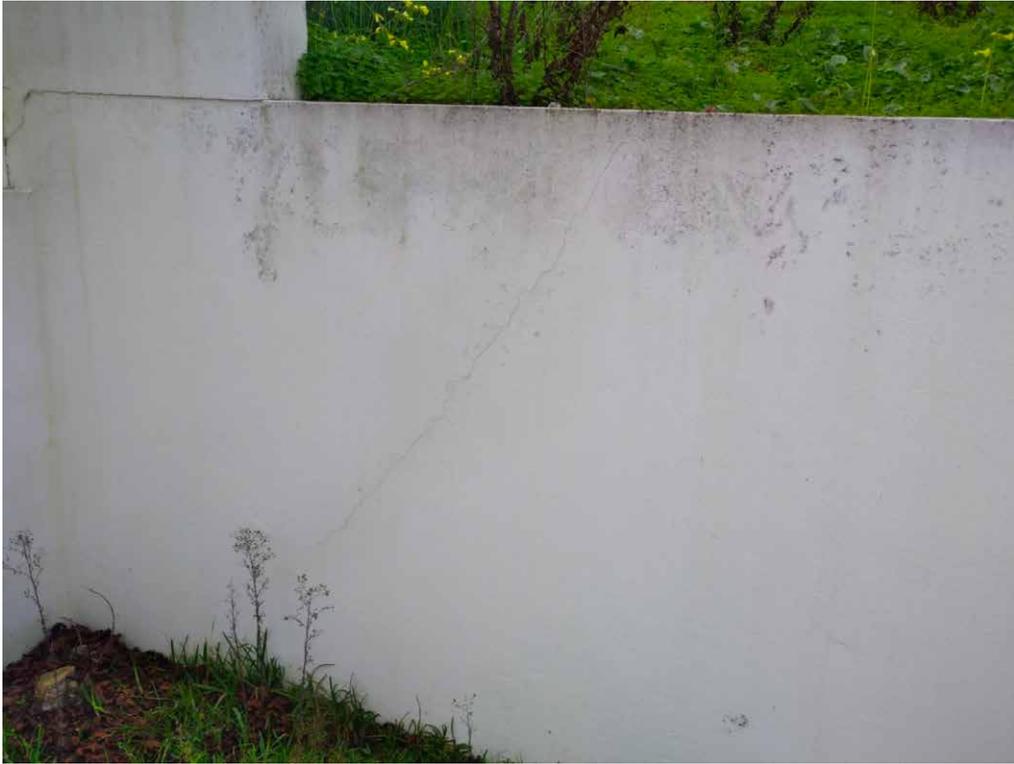
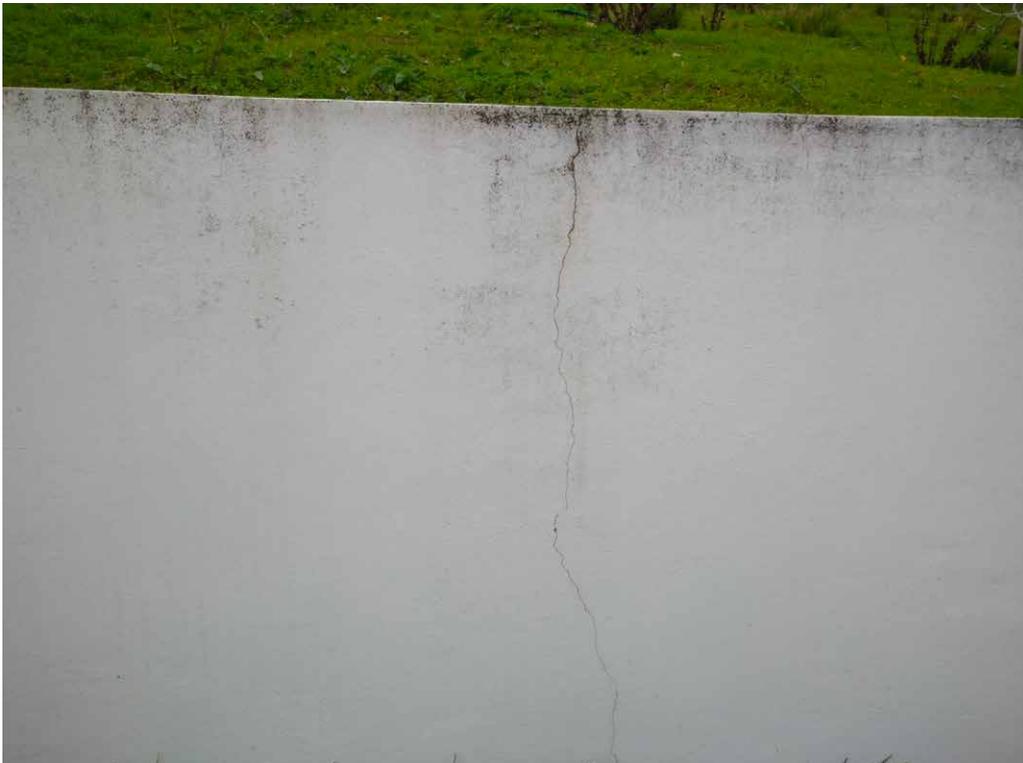
Two cracks have formed (images 4 & 5). Drainage points should be drilled into the wall to allow moisture to escape as necessary.

These can be easily installed by using core drilling equipment. Once the hole is made to the required diameter, a corresponding sized plastic pipe can be inserted into the ground behind allowing for

moisture to escape. These works are done relatively fast. This would be a one day project for professionals. Cost for this is expected to range from 400–600 euros.

These can be repaired with a system known as lacing, this requires steel staples to be inserted in the wall structure over the cracks and tightened. When done the areas are back filled the area re rendered and painted. This system will prevent the cracks returning. Cost 500–800 euros.

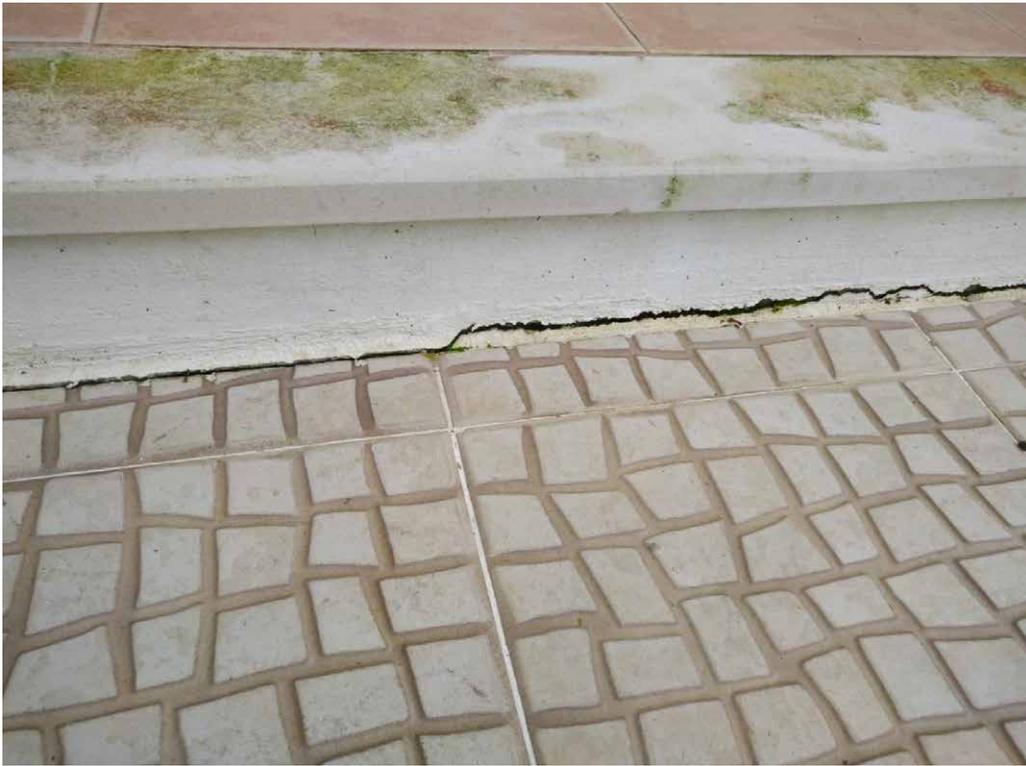
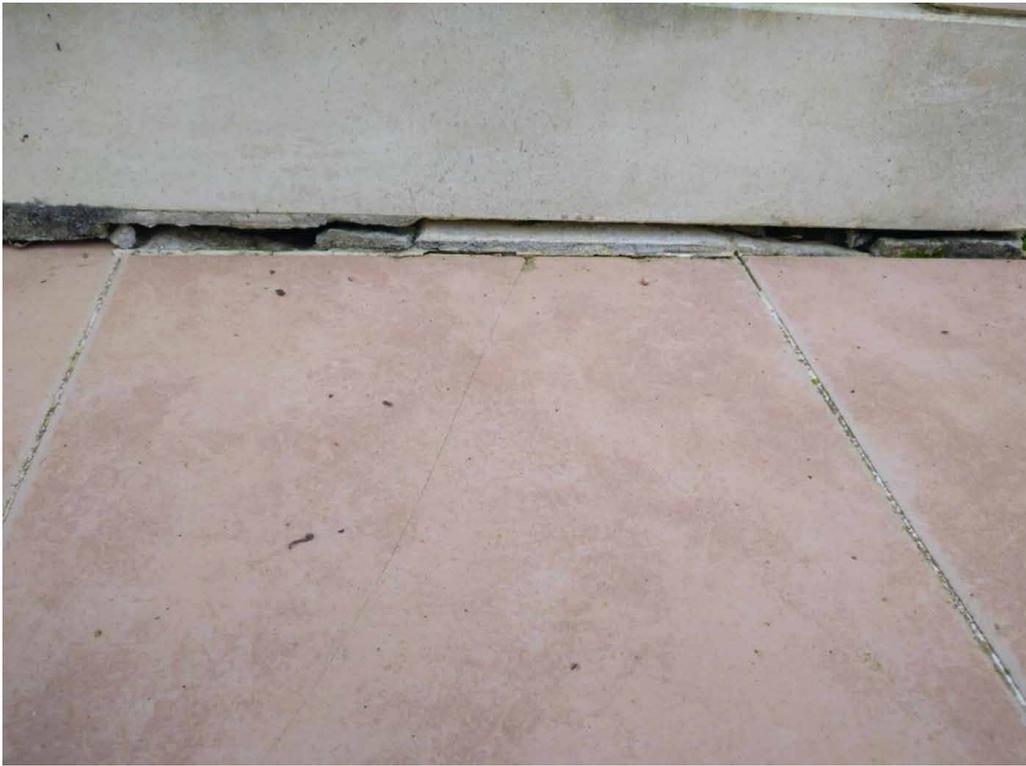
All walkways that run parallel to the house, have begun to subside, creating openings between the two (images 6 & 14) this is due to continued water saturation. The ground under these areas, are absorbing all waters that are left to cascade into the garden areas during the wet season. Then the weight of the walkways causes them to sink into the soft earth. This movement, with the heavy water intrusion, has also caused many tiles to lift and crack (image 13).

Approx. 40 metres of guttering plus down downpipes needs to be installed. Prices for supply and fit could range between 1500–2000 euros. This is only the first step to removing this problem.

Ground works will also be required. A system of underground drainage pipes need to be installed to direct the water away from the residence to the street. This would include cutting into some of the tiled paths, for the inclusion of a catchment system next to the structure, and the digging of trenches to create an area for all the drainage pipes to be installed. Depending on the design of the system and how much area has to be excavated, I would expect this to cost in the region of 3000 euros.

On completion of these works, pathways should cease to subside. To remove the damaged pathways and replace with new would not be cost effective. I would recommend the present cracks be cut neatly open, and then filled with a flexible, water repelling, sealant, possibly Sika Sikaflex. All tiles removed, area grinded back to smooth, a professional primer applied, outdoor tile adhesive, appropriate tiles and a water deflecting grout. The sika product will look correct to the join and prevent further water from finding its way between the foundation and the walkway. Cost should be somewhere between 3000–5000 euros. Works should always be carried out by a larger well known firm, and a guarantee of works should be included.

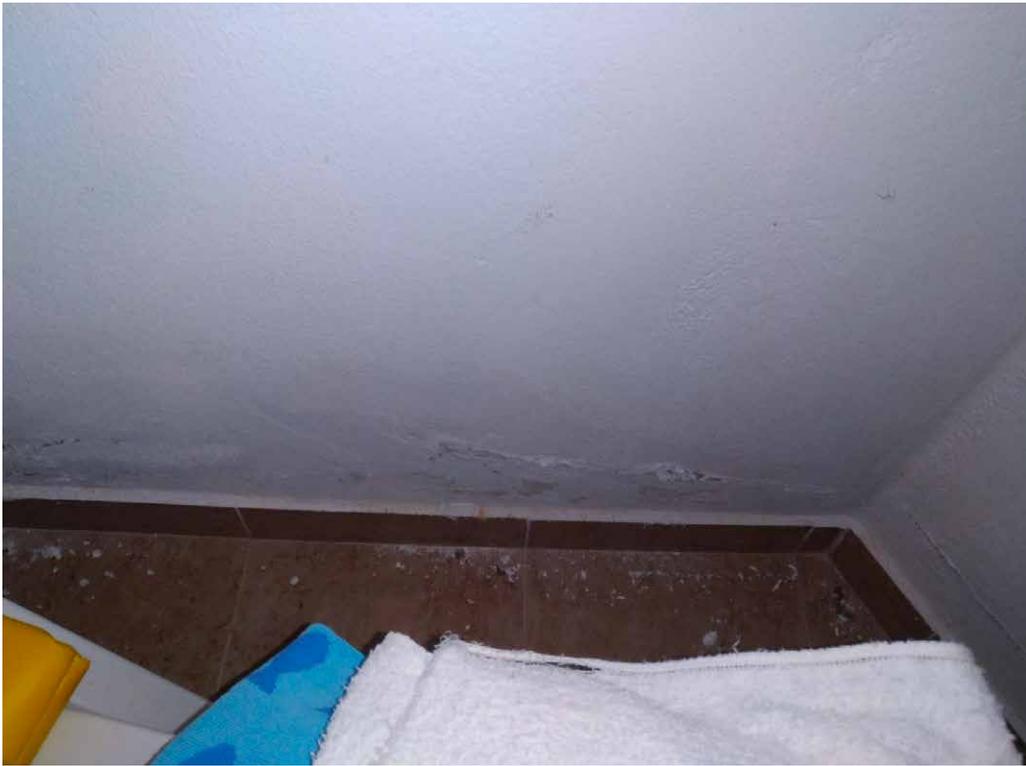
Image 8

This water saturation around the house is affecting the cellar as well. Damp was noted mainly on the rear wall (image 8). This damp has been kept to a minimum, due to a damp course having been added to the foundation during construction (image 15) However this (Platan system) has not been been installed correctly.

Once the gutters and drainage are done, this problem should be reduced dramatically. All walls should be treated against mould, and when painted, ensuring good quality paint is used. This area should always have good ventilation.

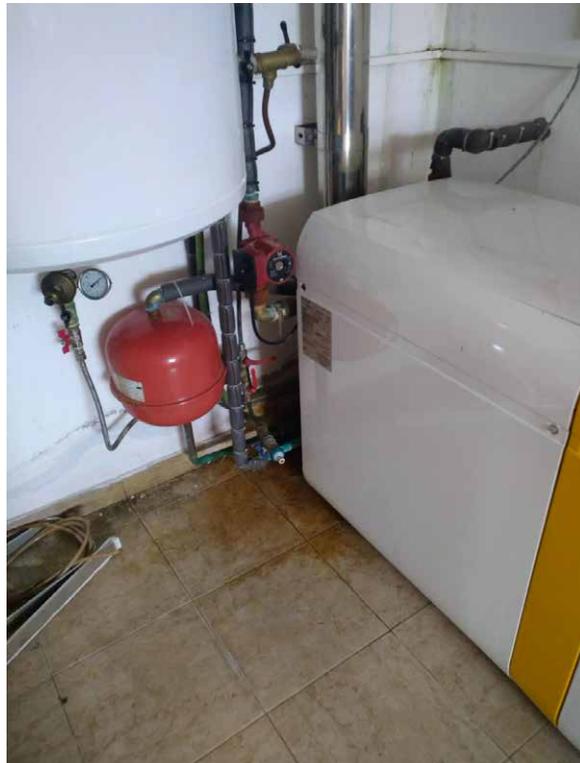
Image 9

This is a gas unit (image 9). This system will need upgrading in the near future. The unit itself was leaking water, many of the fittings were rusty at the joints, and I believe the unit to be approximately 20 years old. Some of the elements in the house have rust at joints, and the element in the living room, had been leaking on the floor.

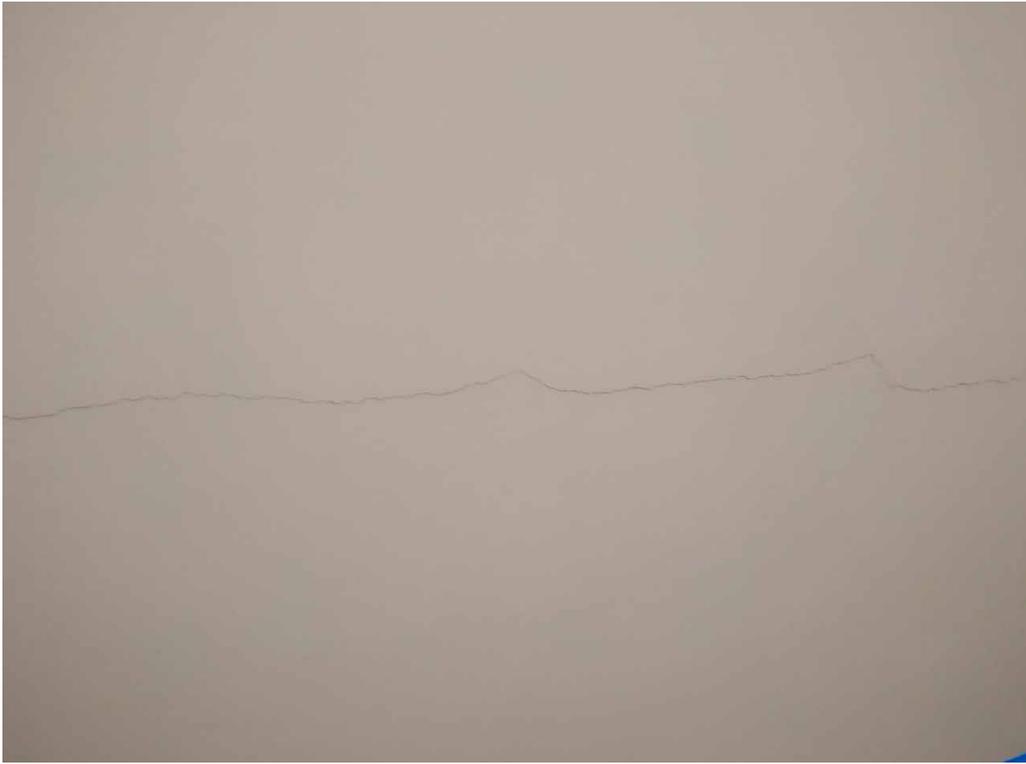
Image 10

These had no major issues. A horizontal crack is visible in the cellar stairwell (image 10). This crack is not structural. Where the bricks meet the concrete has partially separated causing the render to crack. This is repairable.

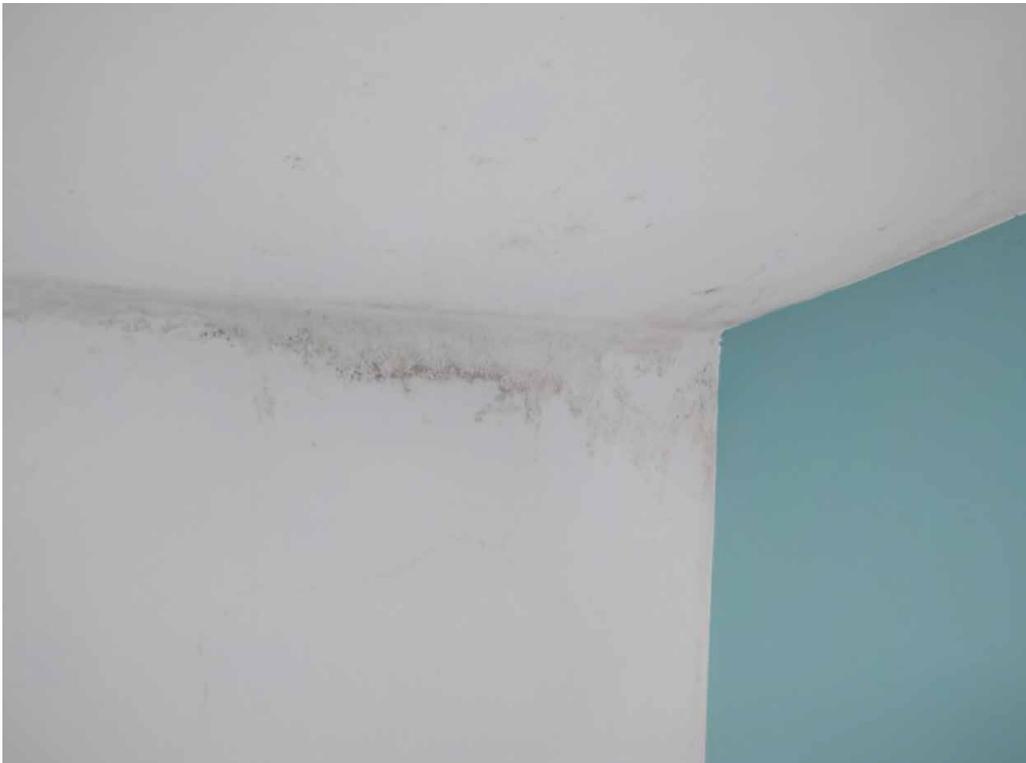
Image 11

Is made using reinforced concrete rafters, hollow bricks placed in-between then skimmed both sides, Roof tiles then placed over concrete battens. The construction is well done and solid. However a leak is occurring into the attic area (image 11) I speculate a small crack has opened in the bricks or between the rafter and a brick, this has allowed water to seep into the attic staining the wall and ceiling.

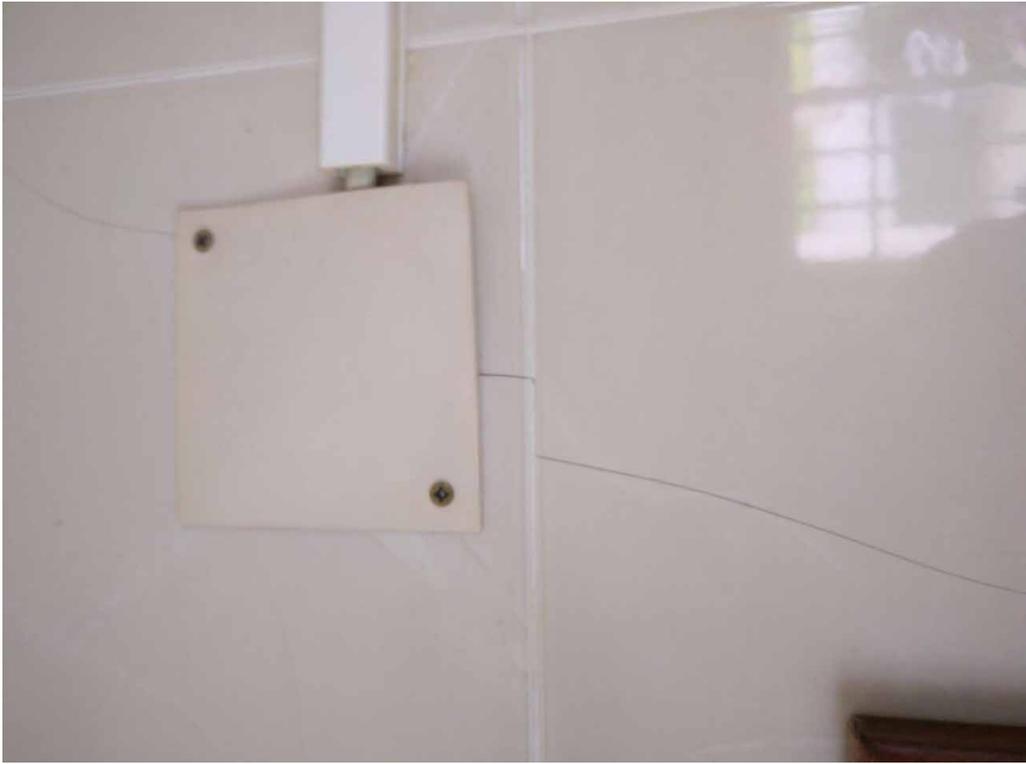
Image 12

The kitchen has some years on it, many of the main components are well past their prime. Gas boiler, overhead exhaust fan, basin. Two tiles have been cracked (image 12).

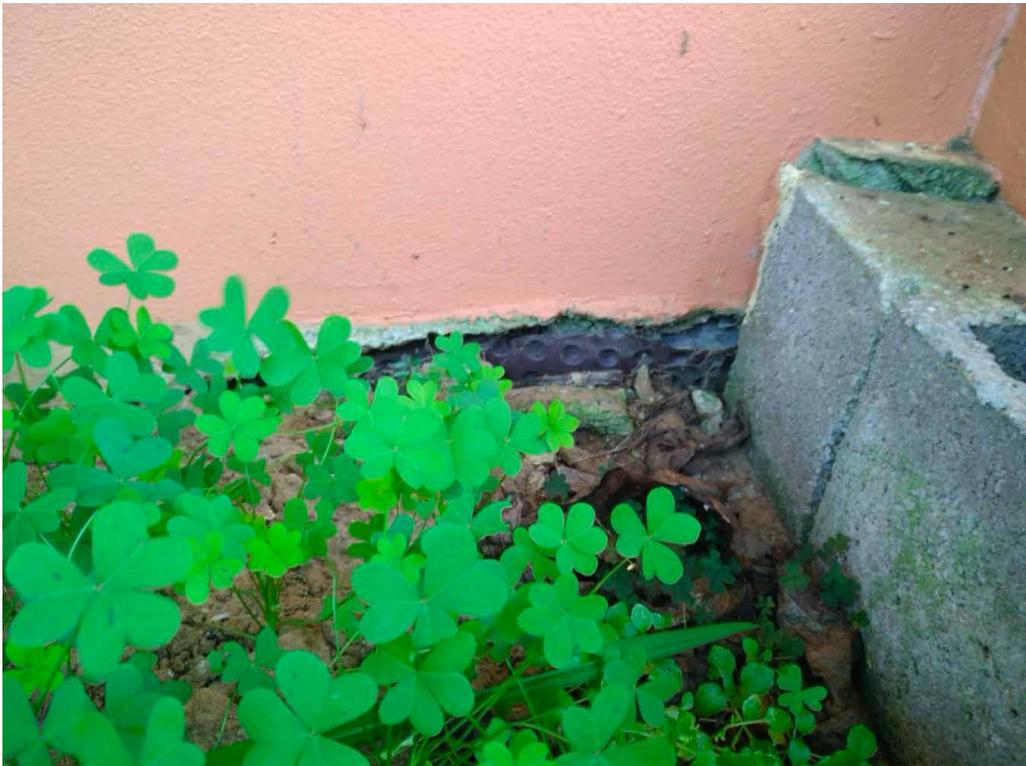
Image 15

The higher section of the plastic sheet is not correctly attached to side of the foundation; an attempt to attach this using the render was visible in the photographed area. I can only speculate that it would be similar at all contact points surrounding the foundation. The installation of a damp course membrane is a very precise procedure.

Having observed the small area that was exposed to me, I can only believe this installation was not done to the highest standard, but is functioning at an acceptable level. The cellar area also benefits from extensive ventilation, which will certainly be helping the area to have reduced damp issues.

It would not be cost effective to attempt an upgrade to this system. I speculate it is working at 90% of its intended effect. Most houses of this era were built without this system, so knowing this has been done is definitely a win and what faults it may have are small in the big picture.
